# Property Inspection Report

**7741 Bankers Drive**  
**Inspection Prepared For: Edward Thornfield**  
**Agent: Amanda Wynn - Country Girl Houses**

**Date of Inspection: 11/12/2022**  
**Year Built: 1995 Size: 2100**  
**Weather: Cloudy**

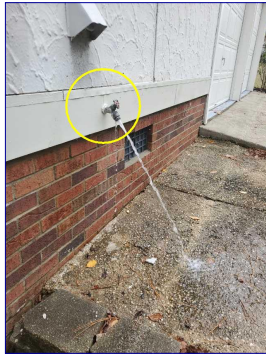
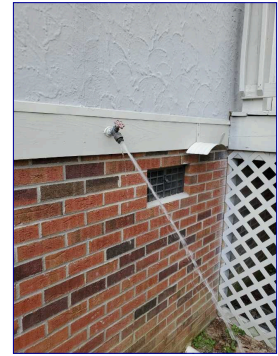
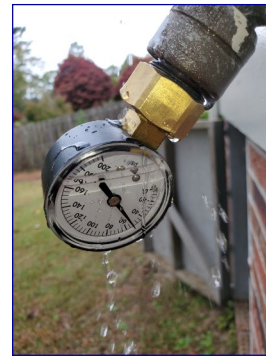
The hose bib is not secured to the house, which may cause damage over time. Recommend securing the hose bib to the house.

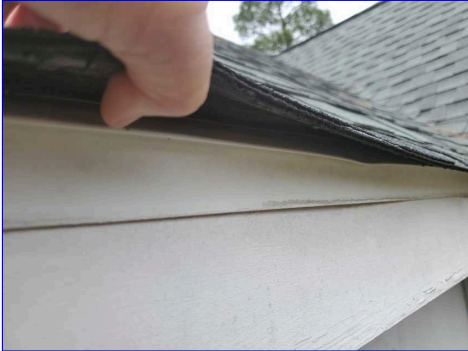
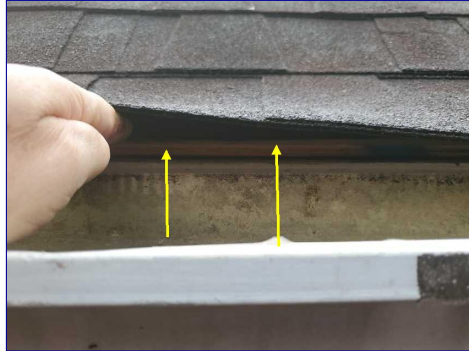
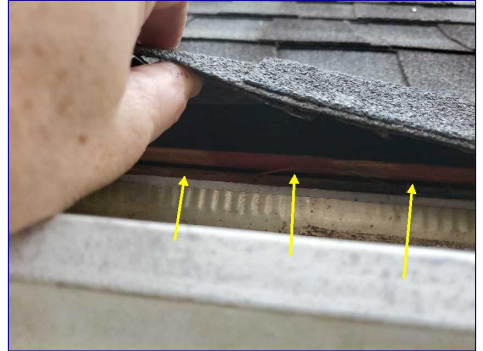
- There was missing **drip edge** flashing in one or more areas of the roof. Recommend a professional contractor install drip edge flashing to help prevent moisture damage.

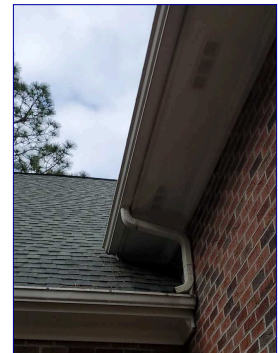
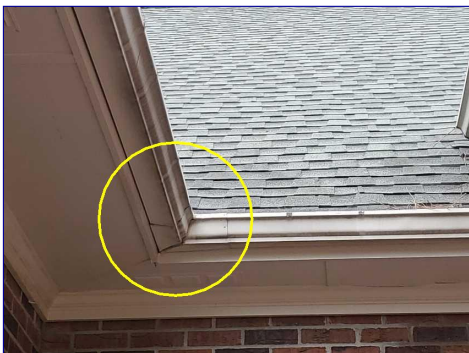
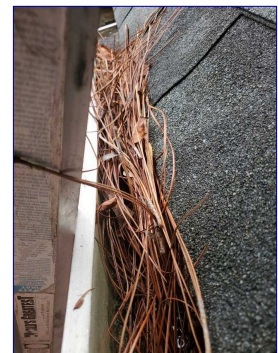
The gutters are dirty. Recommend cleaning the gutters to ensure proper water flow to the downspouts. Gutter leaks in this area.

There is evidence that the gutter is leaking at the seams. Recommend a professional contractor evaluate and repair as needed.

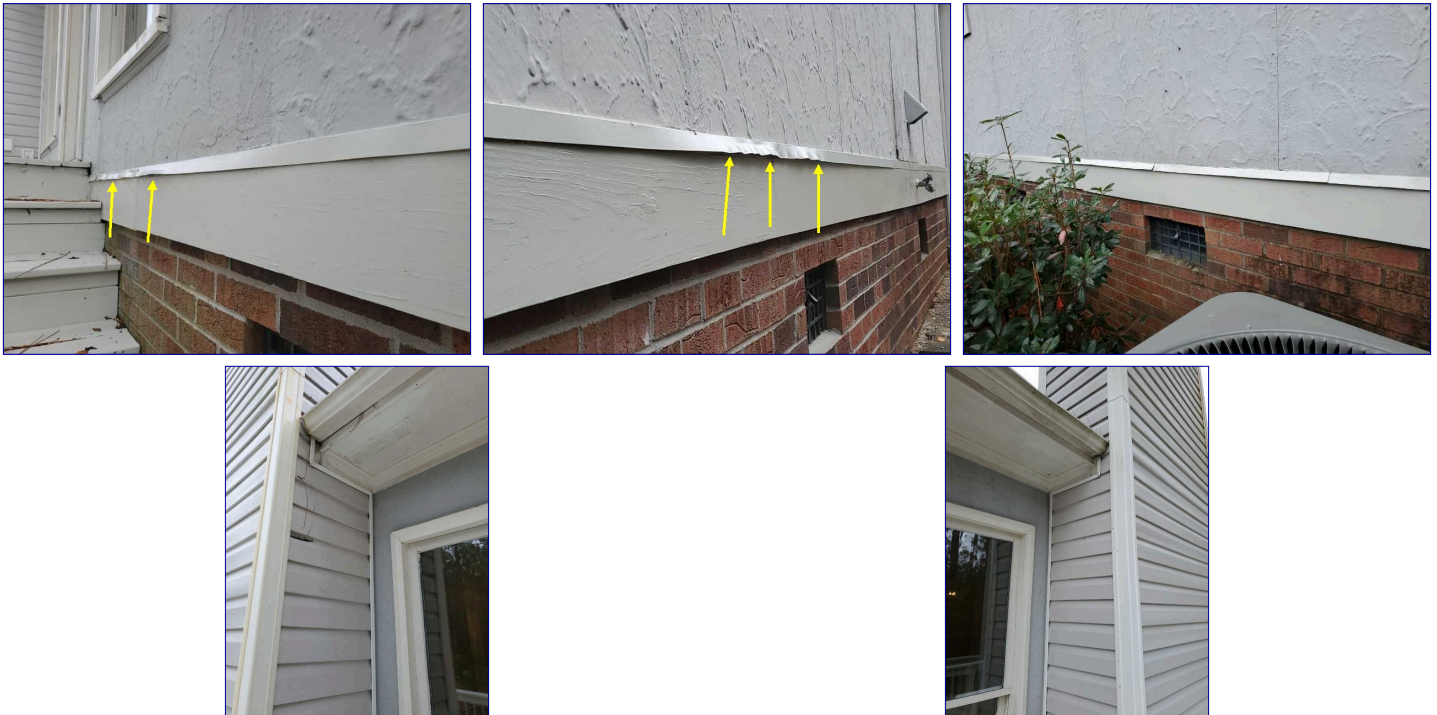
- The exterior flashing needed repair in one or more areas. Recommend a licensed contractor repair to prevent additional damage.

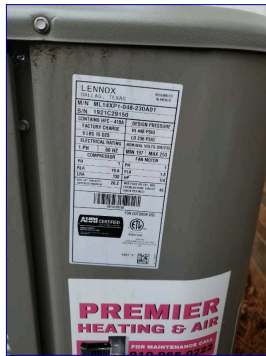
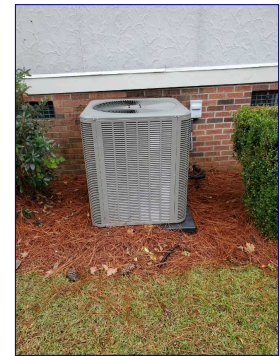
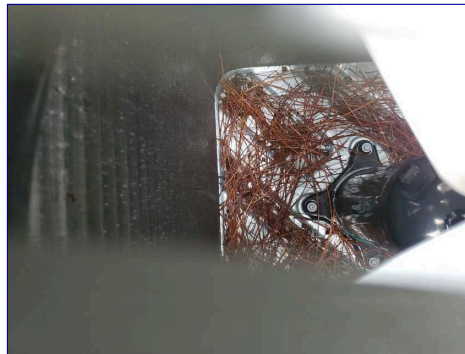
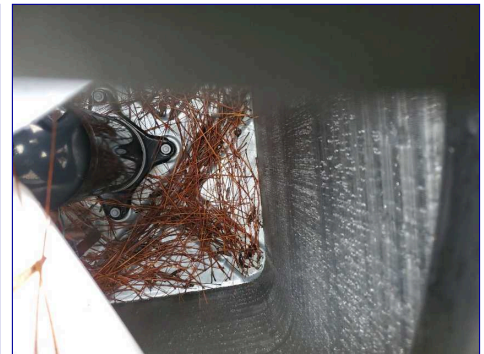
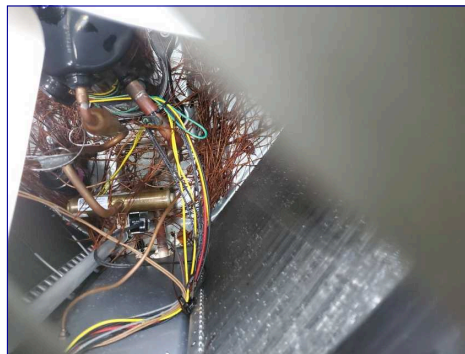
The air conditioning condenser coils are dirty. Recommend cleaning. Consult a professional contractor as needed.

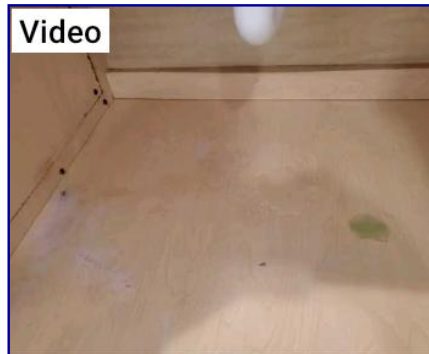
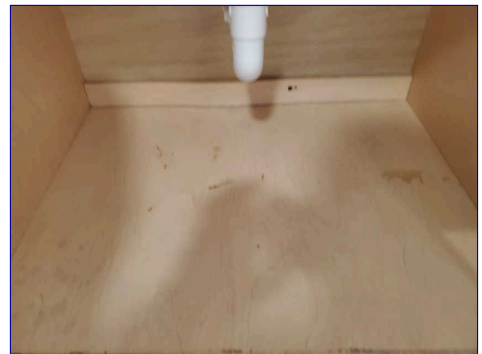
• The drain is leaking in the bathroom 2. Recommend a licensed plumber repair or replace.

The drain is leaking in the bathroom 2. Recommend a licensed plumber repair or replace. Sink on left side.

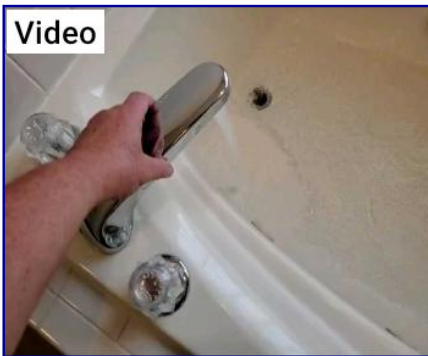
- Bathtub faucet in master bath loose and leaked when turning hot water knob. Recommend repair by qualified plumber.

Bathtub faucet loose.

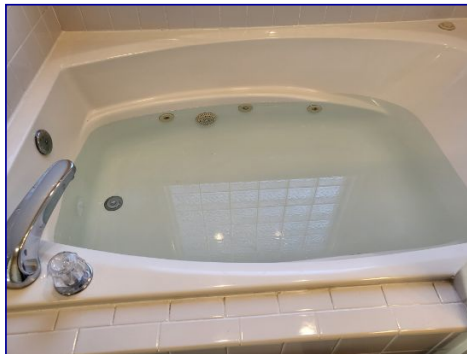
- Whirlpool: Yes
  - Whirlpool, operable: No
- Observations:
- Whirlpool did not operate. Recommend repair by qualified technician.

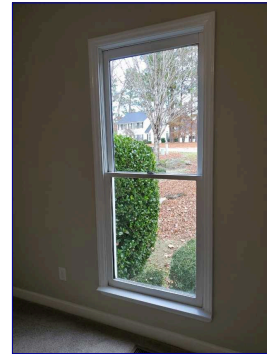
The bedroom egress is restricted in bedroom 2, which is a safety concern. Recommend a licensed contractor repair.

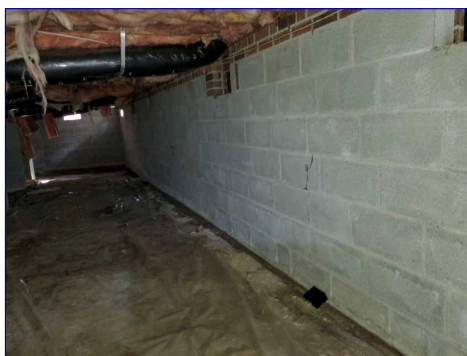
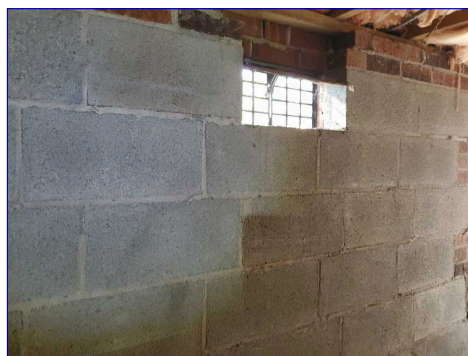
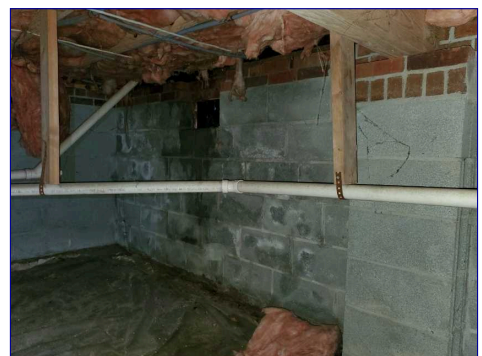
- Materials:
- Concrete block
- Observations:
- Moisture stains present in the crawl space. Monitor and consult a licensed professional as needed.
  - There is efflorescence on the foundation walls. Recommend monitoring and consulting a licensed contractor to repair as needed.

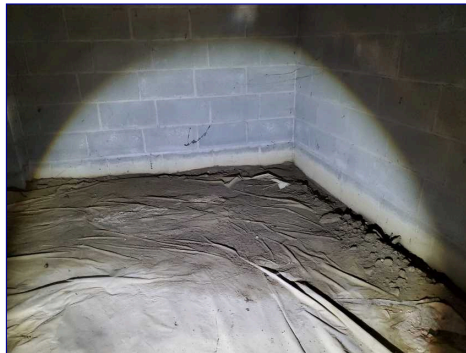
- The crawlspace floor was wet in one or more areas with no standing water present in the crawlspace.

Recommend a licensed contractor install a drain system and plastic vapor barrier to help protect the foundation walls and prevent moisture damage.

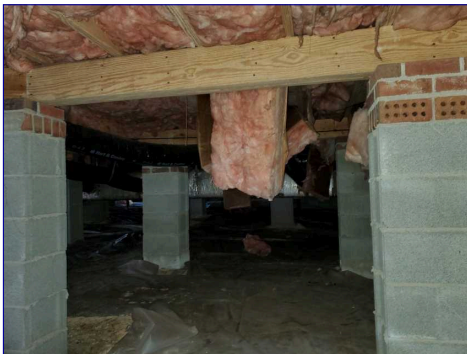
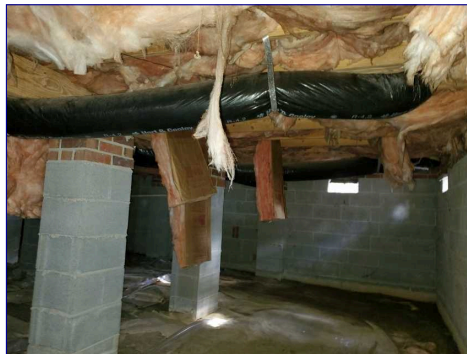
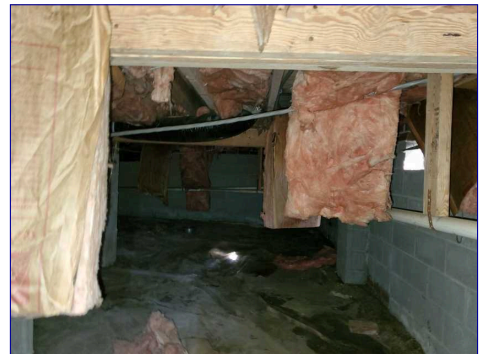
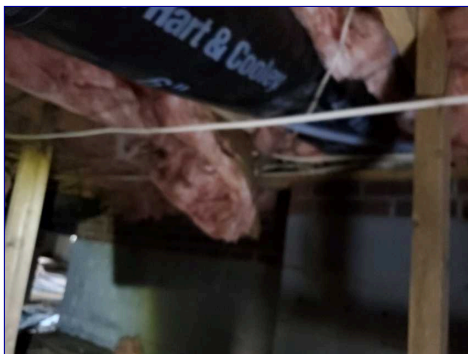
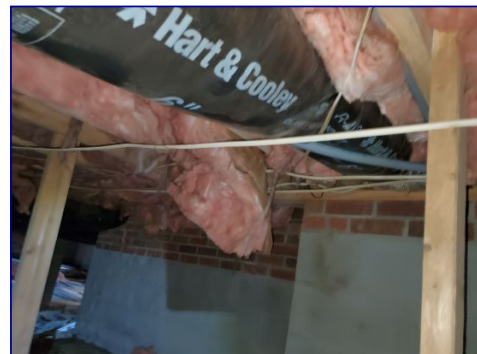
• Insulation between joists in crawlspace was falling in several places. Recommend repair or replace by qualified technician.

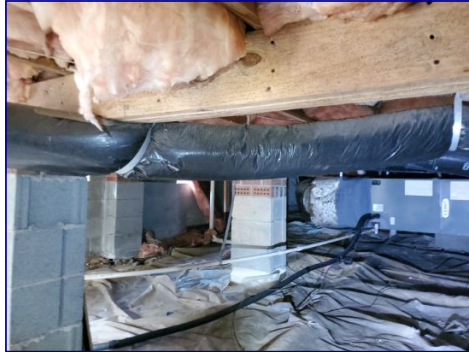
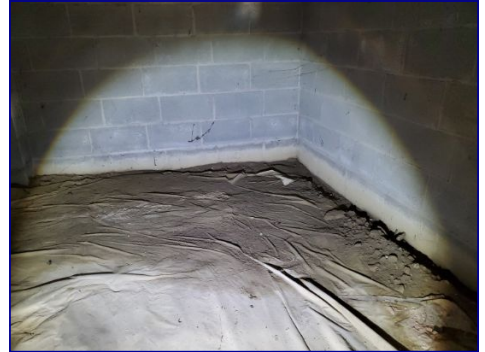
• Vapor barrier in crawlspace is not adequate. Overlap is improper. Much of the Vapor barrier is worn-out. Recommend replacing by qualified technician.

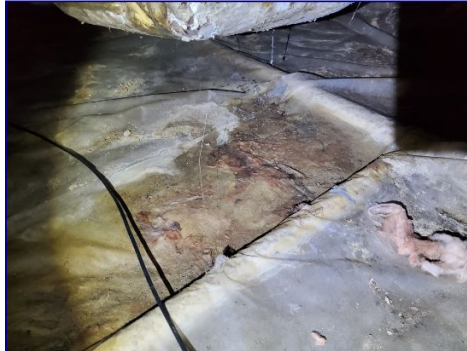
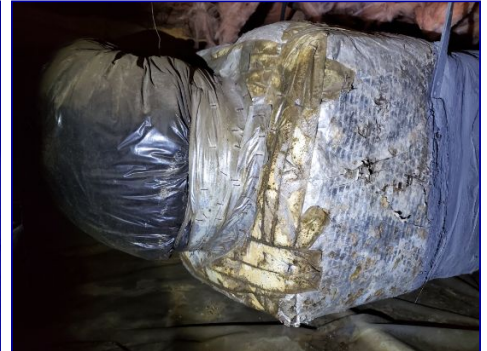
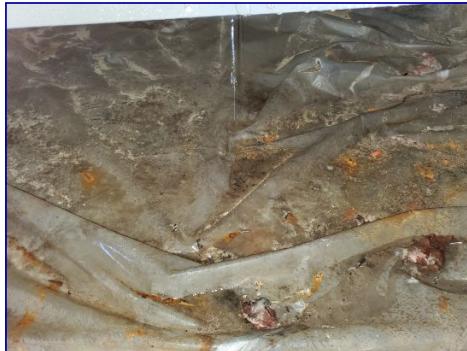
• Recommend HVAC technician examine/clean/service. Water was leaking in several places from under cabinet. Could be from clogged condensate drain line. Recommend additional inspection and repair by HVAC technician.

• There was a lot of water on the ground in the crawlspace due to water leaking from unit. Recommend an HVAC contractor examine the air conditioner compressor and coils before closing.
