Property Inspection Report

Woodpecker Home Inspections

537 Lindsay
Inspection Prepared For: Pompilica Miller
Agent: John Powers - EXIT REALTY PREFERRED

Date of Inspection: 10/20/2022
Year Built: 41 Size: 1350
Weather: Partly Cloudy

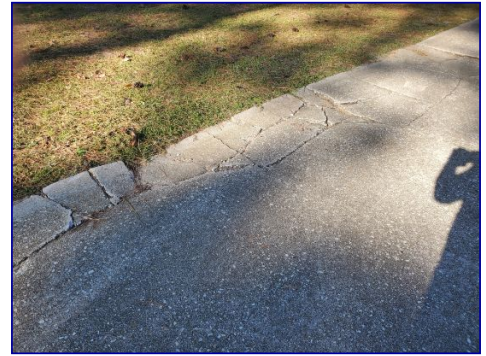
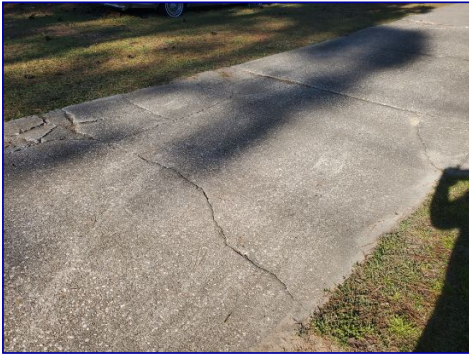
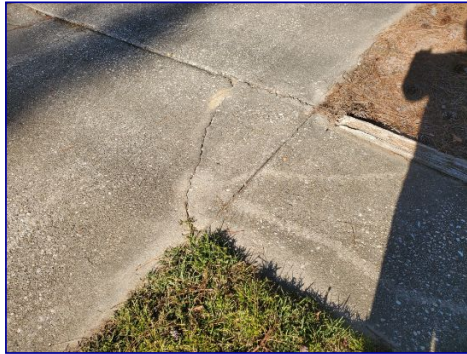
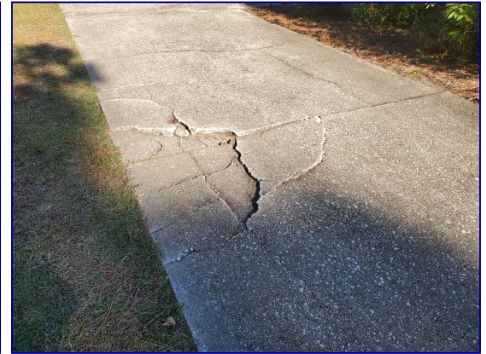
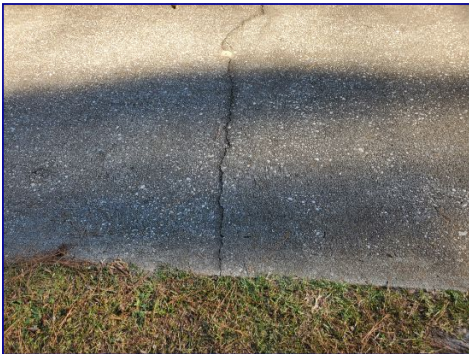
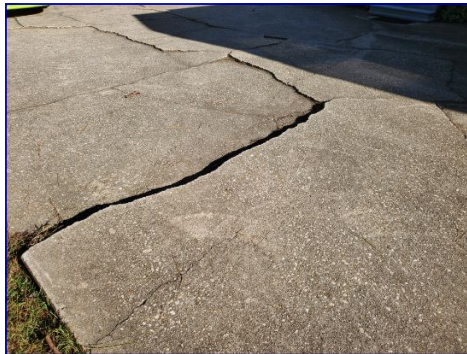
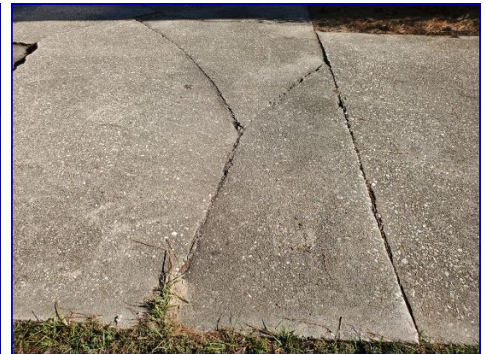
- There are uneven slabs at the driveway, which could be a tripping hazard. Recommend using additional caution in these areas. Repair or replace as needed.
- The driveway is cracked. Recommend sealing the cracks to help prevent additional damage. Consult a professional contractor as needed.

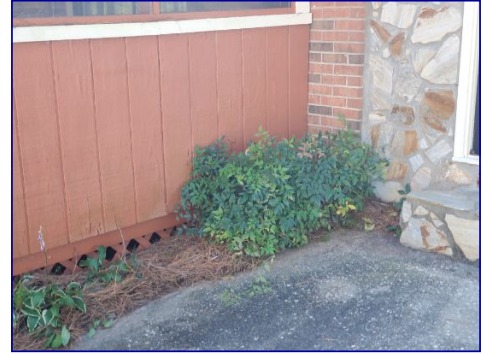
- There is vegetation in contact with the house. Recommend trimming trees/vegetation, so it doesn't come into contact with the home.

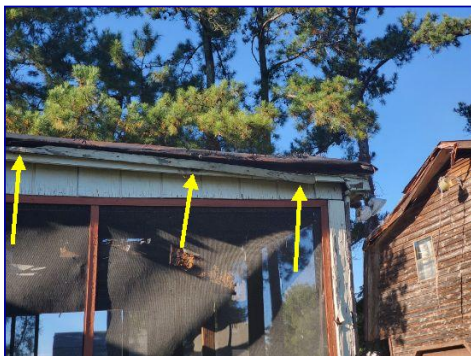
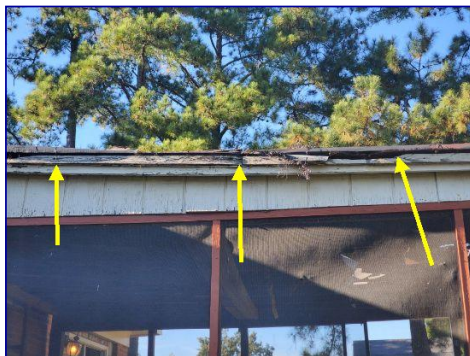
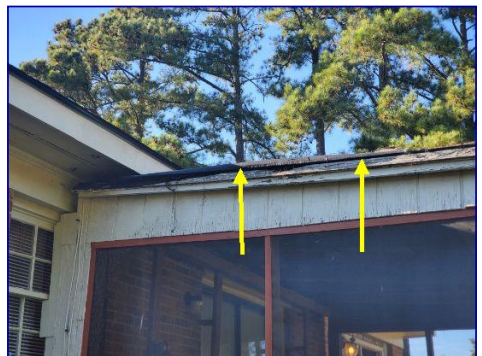
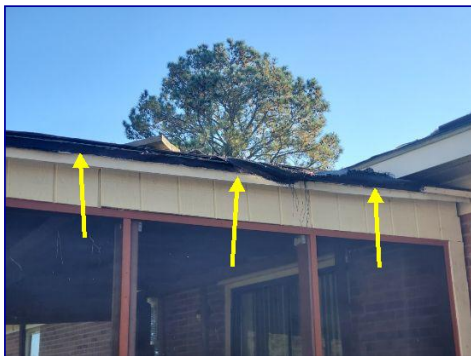
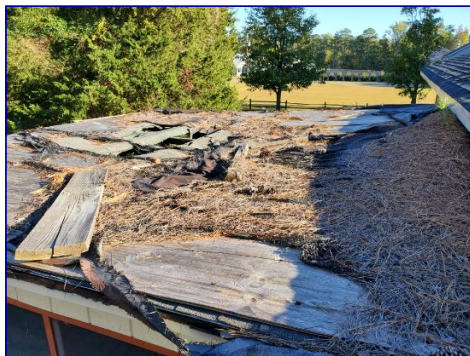
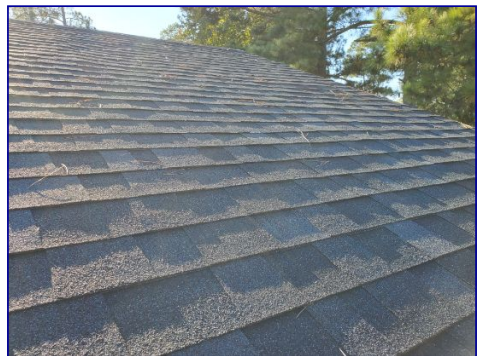
• The roof over the rear deck was in poor condition and will need repair or replacement by a professional roofer soon.

Roof over cover deck.

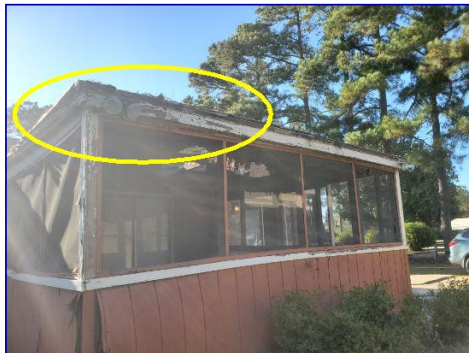
- Some of the trim was damaged. Recommend repair or replacement of damaged exterior trim by a licensed contractor.

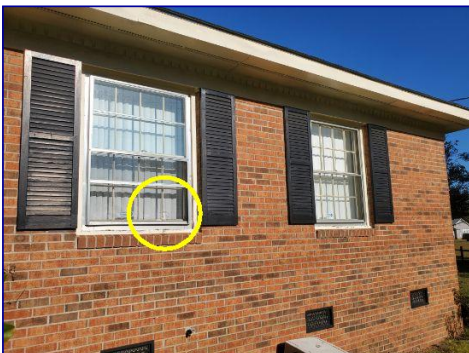
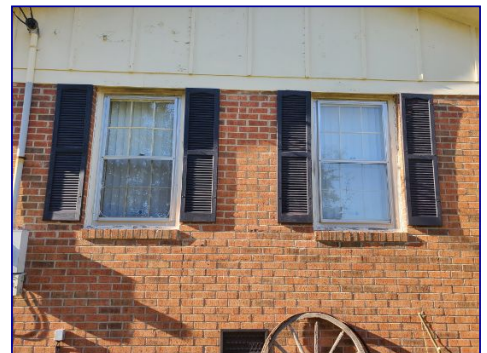
- Some window screens are torn, damaged, or missing. Repair as needed.

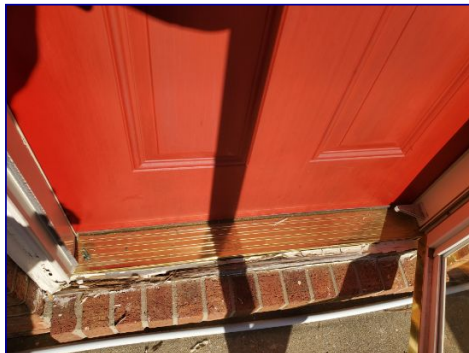
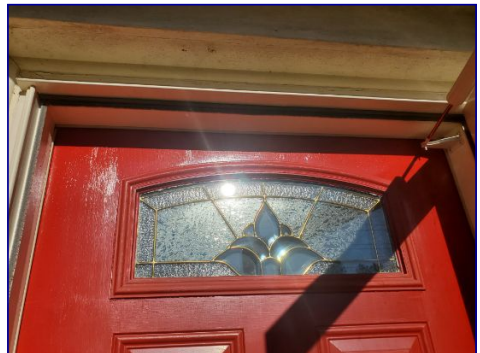
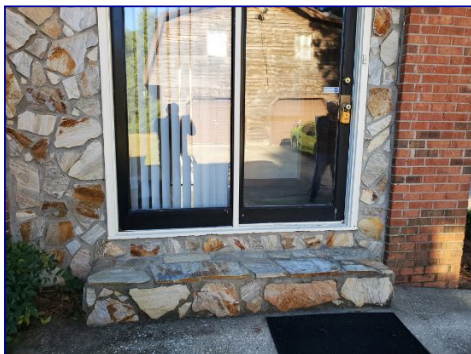
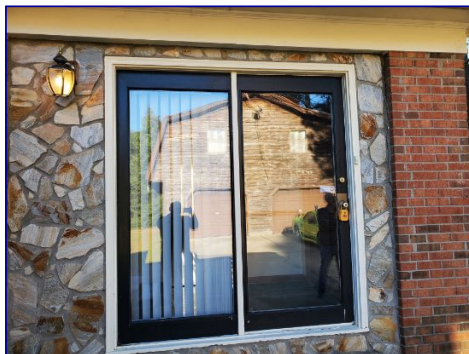
• Main entrance door condition: Satisfactory
• Patio door condition: Poor
• Rear door condition: Poor

- Double cylinder deadbolt exists on at least one exterior door (keyed inside and outside). This is a potential safety hazard. Recommend replacing with non-keyed locks.
- The patio door does not slide easily. Recommend a professional contractor repair.
- The entry doorjamb was busted and damaged and does not fasten the door securely. Recommend a professional contractor repair or replace the doorjamb as needed.

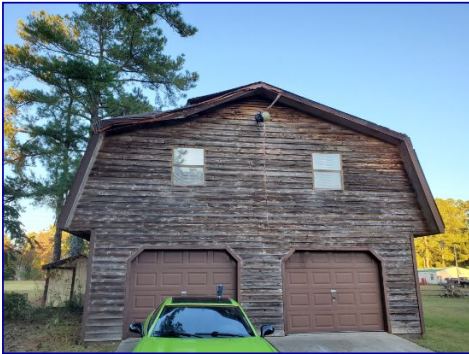
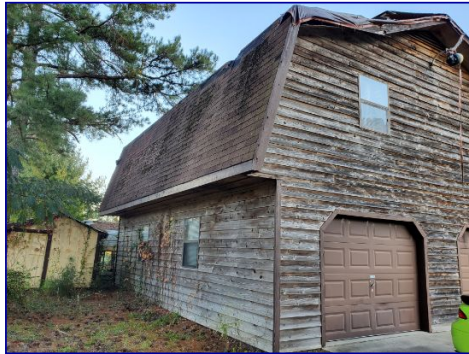
• The roof was in poor condition and will need repair or replacement by a professional roofer soon.

Damaged roof on garage

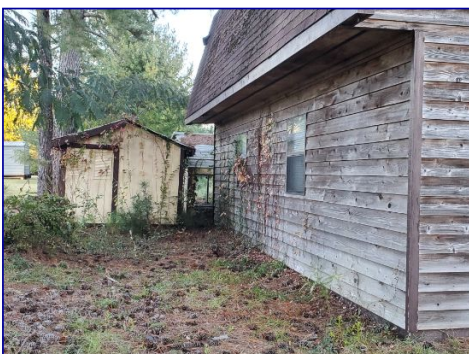
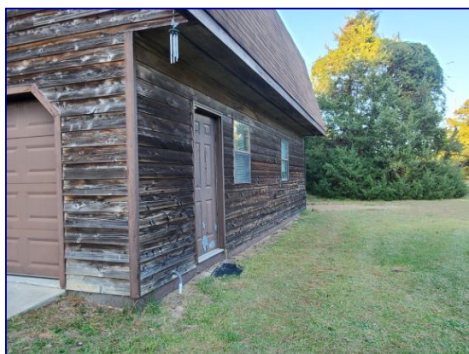
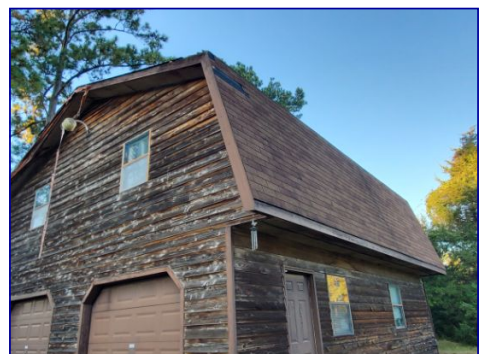
- The siding had some damage, recommend a licensed contractor repair/replace damaged sections.

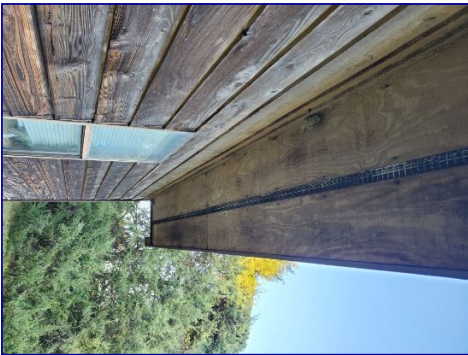
- The garage exterior trim needed routine painting maintenance. Recommend a professional painter repair/paint the exterior trim.

Delaminated soffit

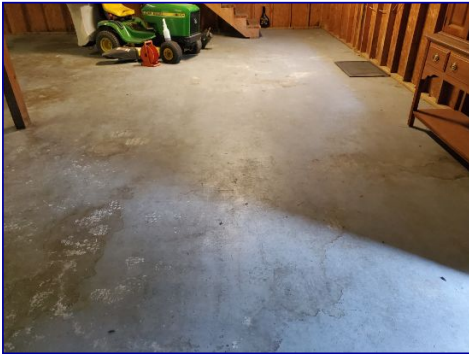
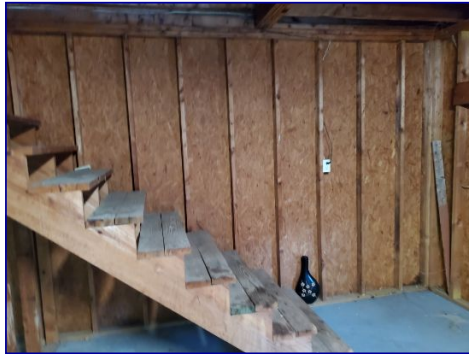
- The garage floor was covered with stored items. The floor could not be completely inspected. Monitor and repair as needed.
- The garage had a stair case going to the loft of the garage. The stairs were missing railings and balusters. This is a safety hazard. Recommend adding railing by a qualified technician.

No railing on stairs, safety hazard

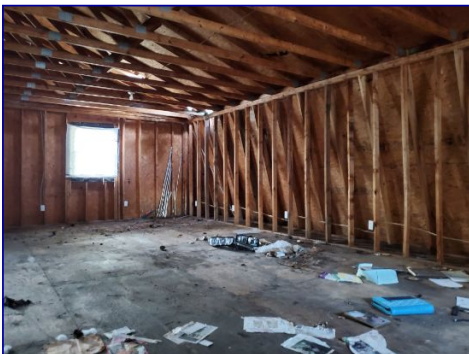
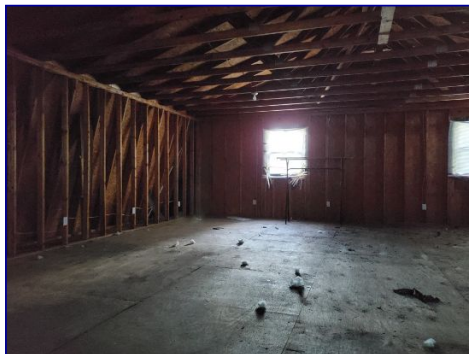
No railing around stairs upstairs. This is a safety hazard

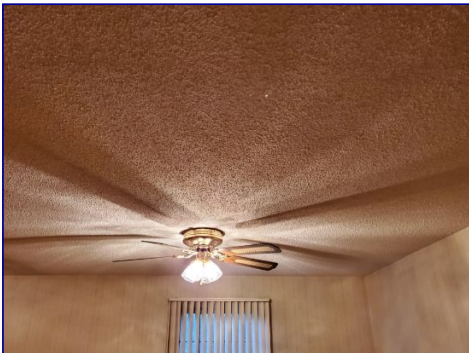
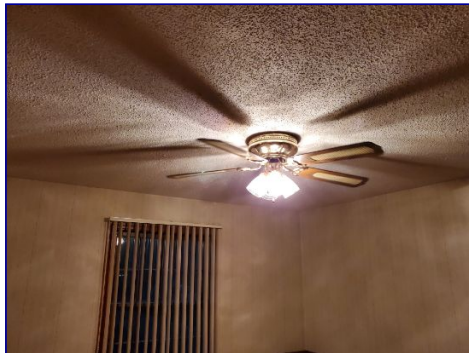
- The ceiling fans were making noise when operating. Repair or replace as needed.

Operated but made noise

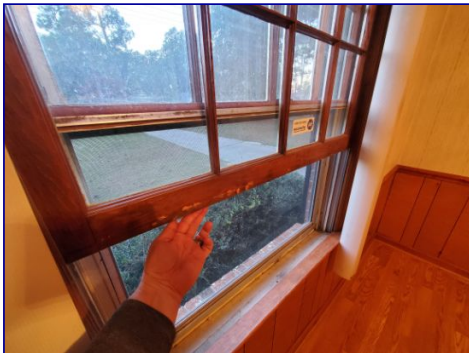
- One or more window springs are broken or would raise. Recommend a professional contractor repair.

Window would not stay in up position.

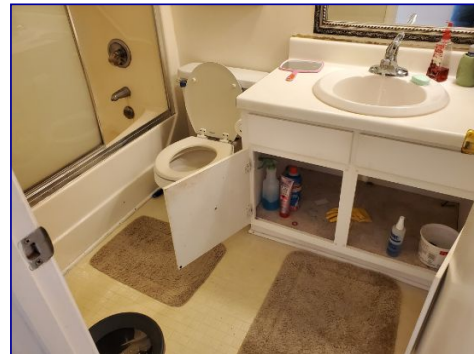
• Pipes are leaking in the bathroom 1. Recommend repair or replacement by a licensed plumber.

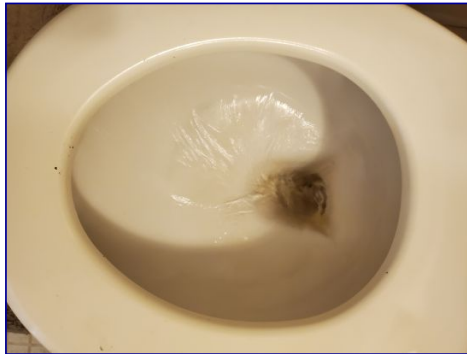
• Toilet would not flush. Water was turned off. Supply line to tank leaked.

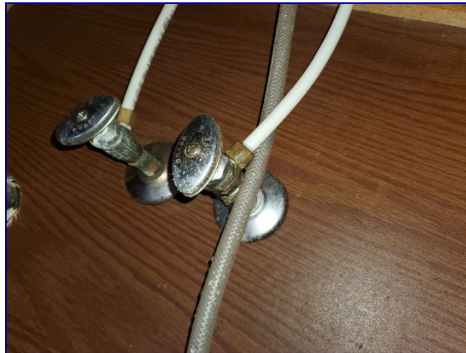
- Pipes are leaking in the bathroom 2. Recommend repair or replacement by a licensed plumber.
- The drain is leaking in the bathroom 2. Recommend a licensed plumber repair or replace.

Drain pipe leak

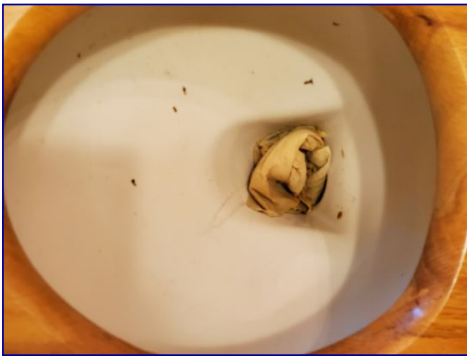
Would not flush.

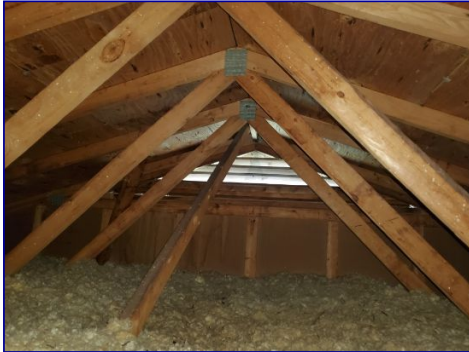
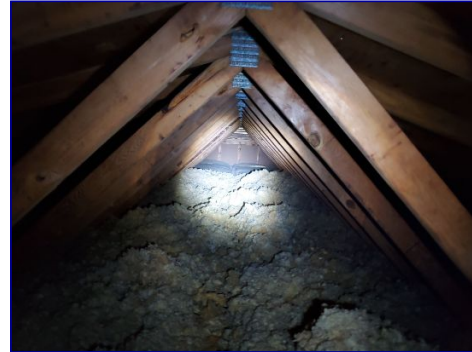
- The soffit vents, as viewed from the attic, are missing baffles. Recommend a professional contractor install baffles at the eaves for proper ventilation.
- Recommend additional ventilation in the attic space. Calculating the attic ventilation is out of scope for a home inspection; however, there were visible deficiencies. Recommend a licensed contractor add additional ventilation.

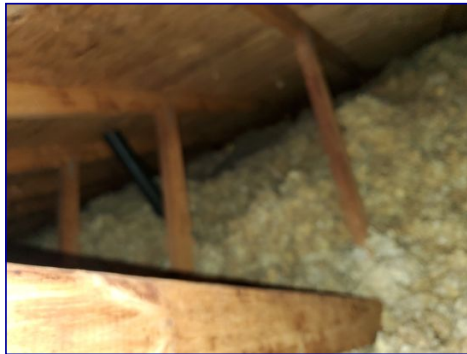
- Bathroom vents terminate in the attic. Recommend extending bathroom vents in the attic to the exterior.

Bath exhaust to outside.

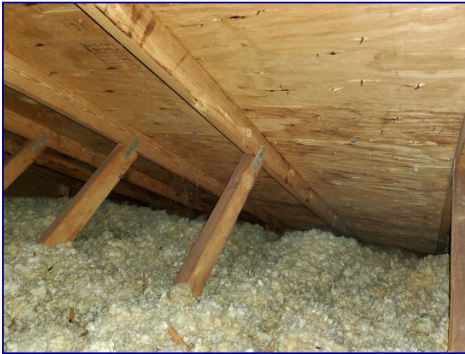
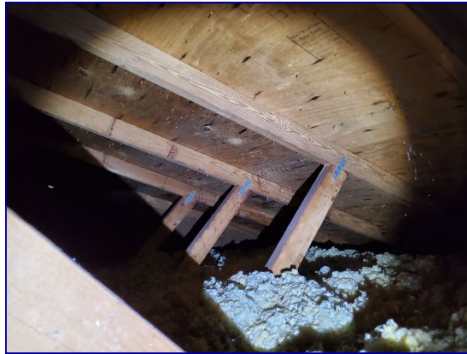
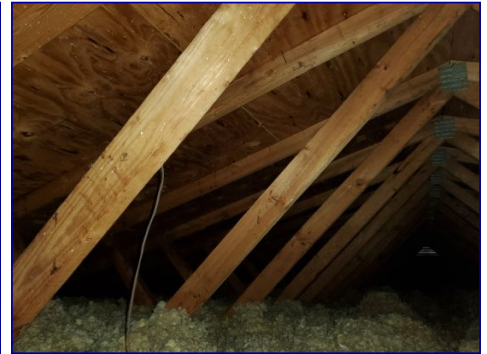
Possible moisture stains from previous roof leak

• There is staining and evidence of moisture on the roof sheathing as viewed from the attic. Possibly from a previous leak. There were no evidence of active leak..

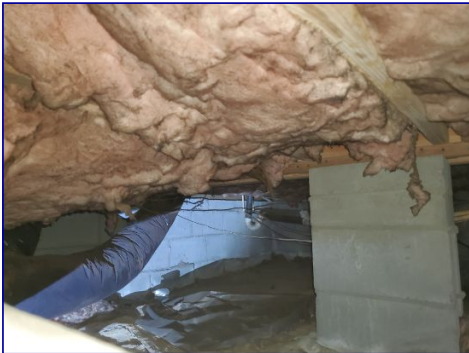
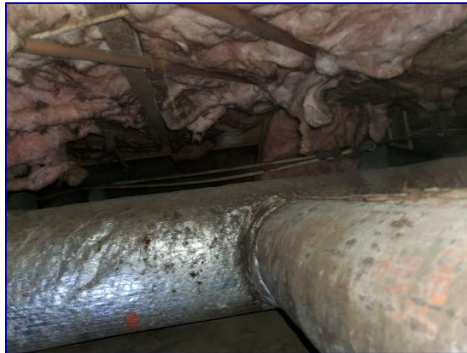
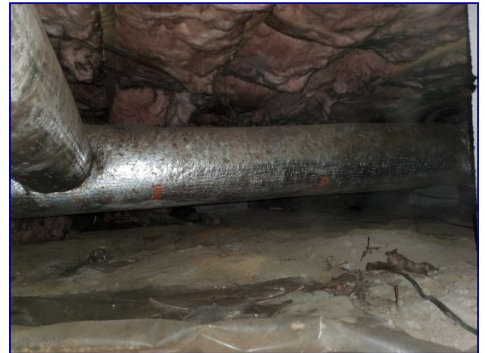
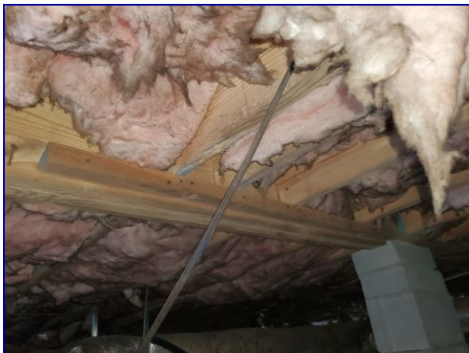
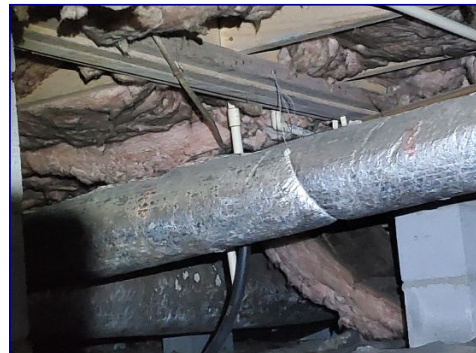
- Materials:
- Fiberglass
- Location:
- Between ceiling joists
- Observations:
- Insulation in the crawlspace is falling from between floor joist. This would allow moisture to reach subfloor. Recommend replacing or repair Insulation in crawlspace.

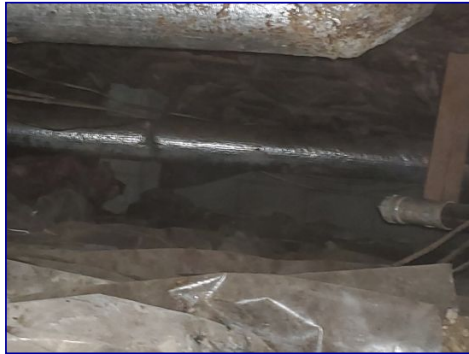
- Vapor Barrier:
- Plastic
- Observations:
- The vapor barrier is missing or damaged on the crawlspace floor. The vapor barrier is used to prevent ground moisture from moving up and into the living area of the home. Recommend a licensed contractor install a proper vapor barrier.

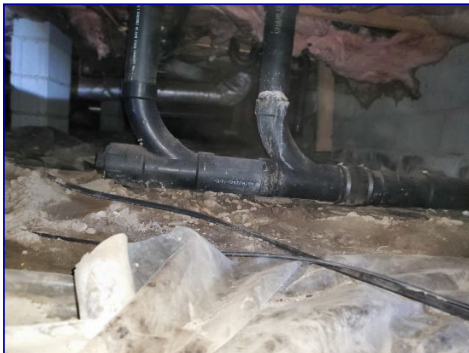
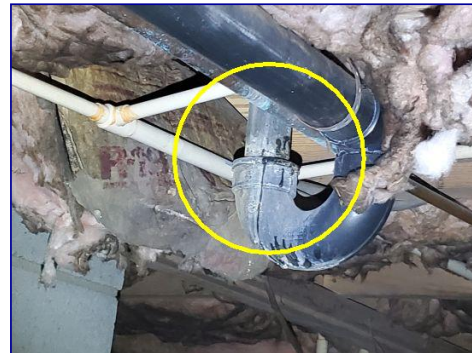
- Plastic drain piping, as seen in the crawlspace, was leaking. Recommend repair or replace by a qualified plumber.

Leak found on this drain pipe

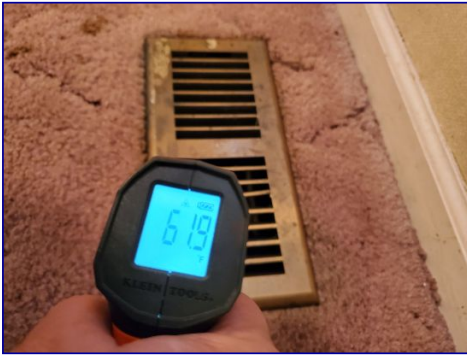
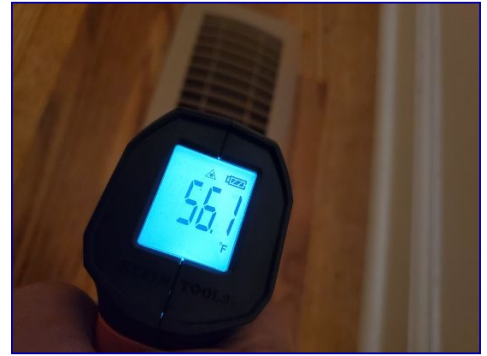
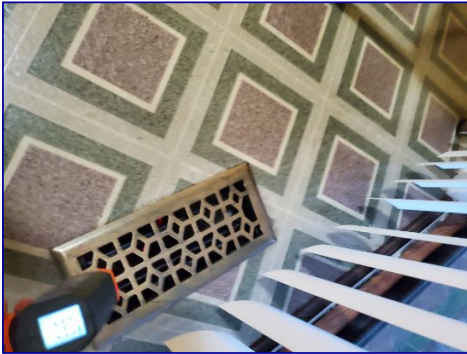
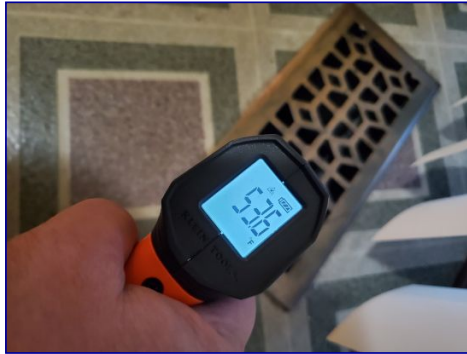
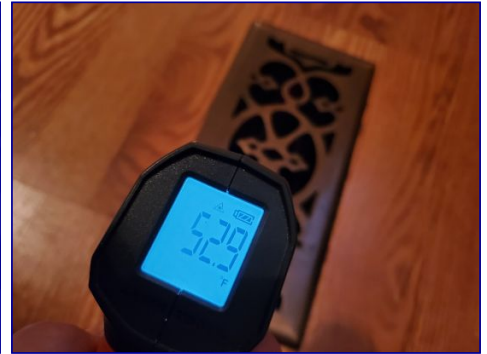
- The air conditioner temperature differential was lower than normal operating standards. The system was not operating as designed. Recommend a licensed HVAC contractor evaluation and cleaning service.

- The refrigerant line has missing insulation. Recommend installing insulation.
- Recommend an HVAC contractor examine the air conditioner compressor and coils before closing.
