# Property Inspection Report

**7741 Bankers Drive**  
**Inspection Prepared For: Edward Thornfield**  
**Agent: Amanda Wynn - Country Girl Houses**

**Date of Inspection: 11/12/2022**  
**Year Built: 1995 Size: 2100**  
**Weather: Cloudy**

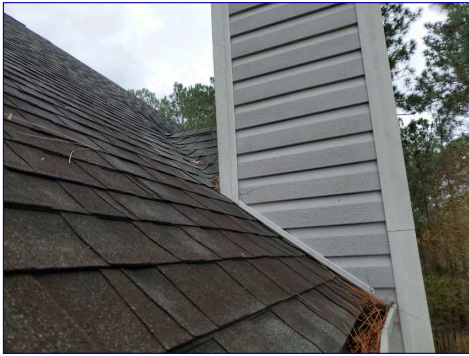
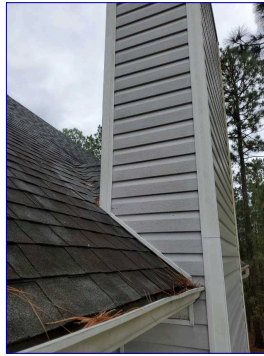
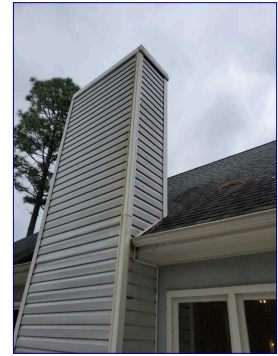
- The gutters are dirty. Recommend cleaning the gutters to ensure proper water flow to the downspouts.
- Gutters on only a portion of the house. Recommend a licensed roofer add gutters to properly direct water flow away from the home and the foundation.
- Gutters had some damage. Recommend a licensed professional to repair or replace damaged and leaking sections.

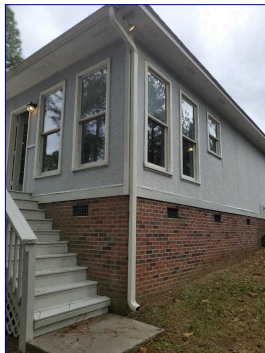
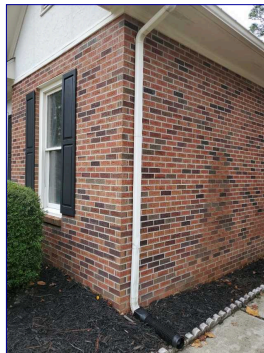
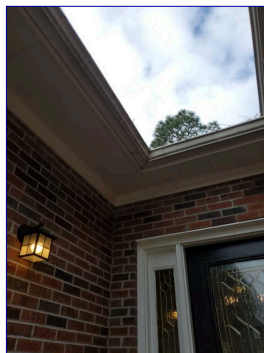
The gutters are dirty. Recommend cleaning the gutters to ensure proper water flow to the downspouts. Gutter leaks in this area.

There is evidence that the gutter is leaking at the seams. Recommend a professional contractor evaluate and repair as needed.

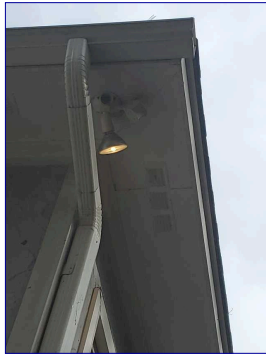
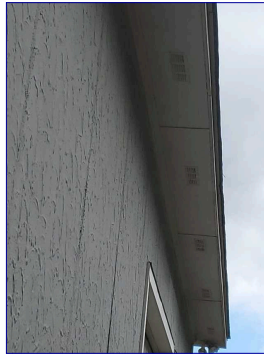
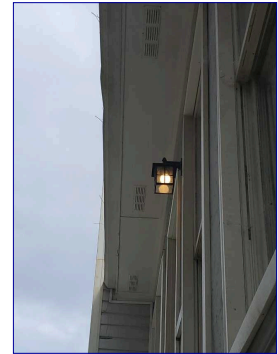
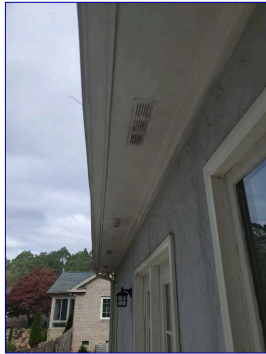
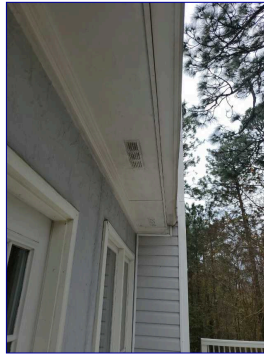
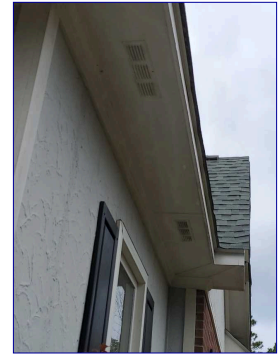
- The fascia needs routine painting maintenance. Recommend a professional painter repair/paint the fascia.

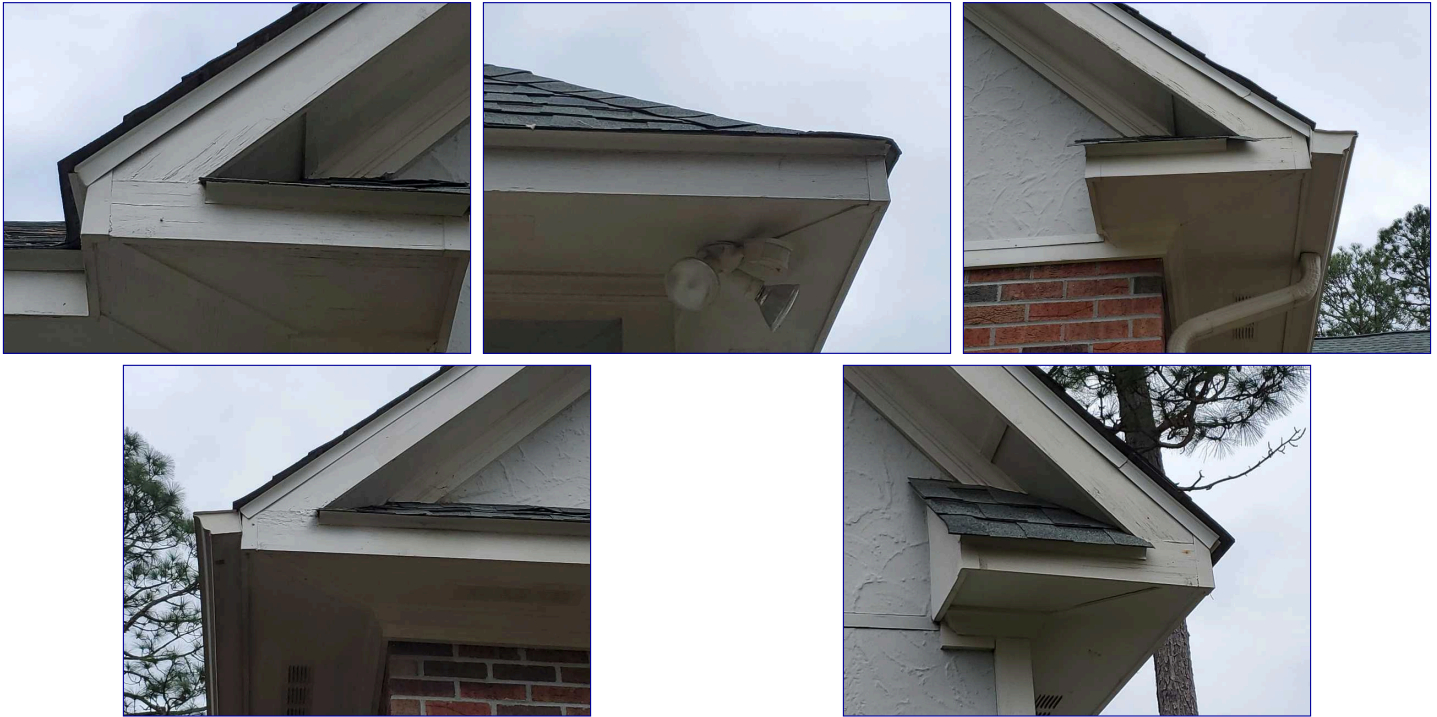
- The exterior flashing needed repair in one or more areas. Recommend a licensed contractor repair to prevent additional damage.

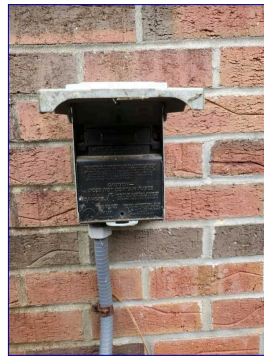
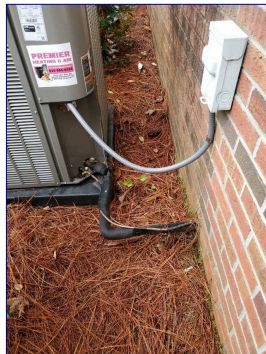
The air conditioning condenser coils are dirty. Recommend cleaning. Consult a professional contractor as needed.

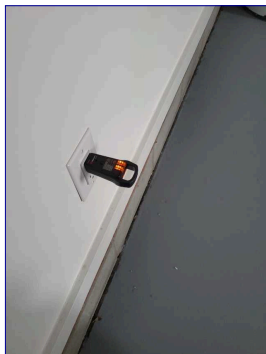
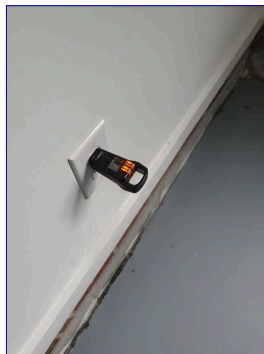
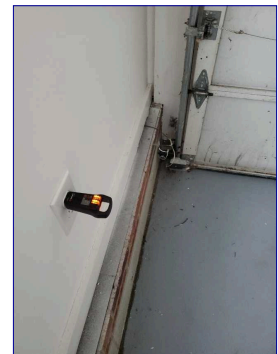
## 13. Electrical Receptacles

- Electrical receptacles: Yes
- Electrical receptacles, operable: Yes
- GFCI present: Yes
- GFCI operable: Yes
- Overhead lights did not work during inspection. Recommend repair or replace by qualified technician or electrician.

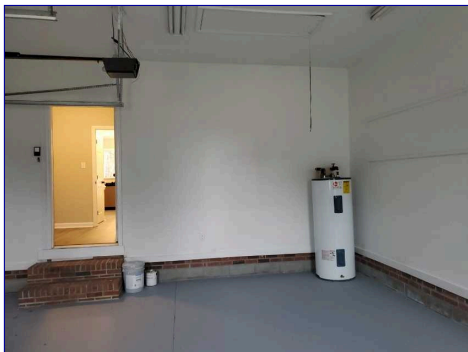
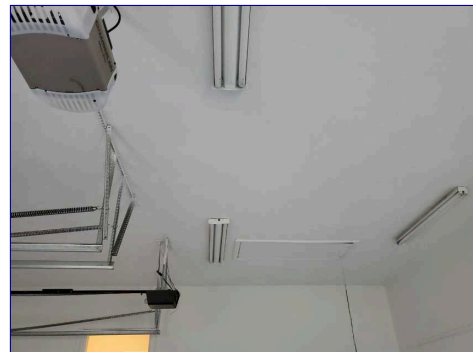
## 14. Fire Separation Walls & Ceiling

- Fire Wall:
- Fire door self closure: Missing

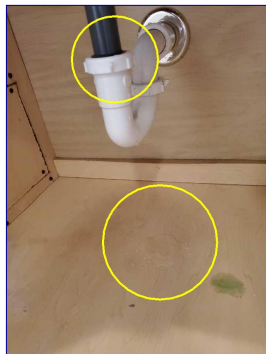
• Faucet leaks: No  
• Pipes leak: Yes  
Observations:

• The drain is leaking in the bathroom 2. Recommend a licensed plumber repair or replace.

The drain is leaking in the bathroom 2. Recommend a licensed plumber repair or replace. Sink on left side.

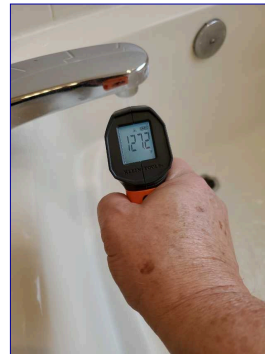
- Faucet leak: Yes

- Bathtub faucet in master bath loose and leaked when turning hot water knob. Recommend repair by qualified plumber.

Bathtub faucet loose.

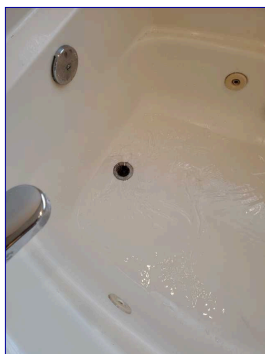
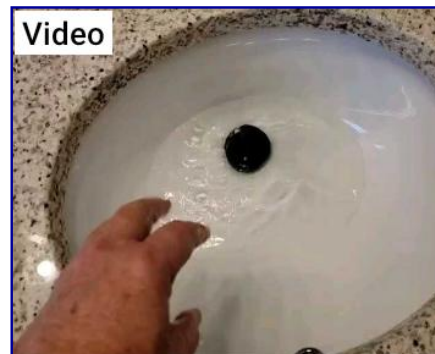
- Whirlpool: Yes
  - Whirlpool, operable: No
- Observations:
- Whirlpool did not operate. Recommend repair by qualified technician.

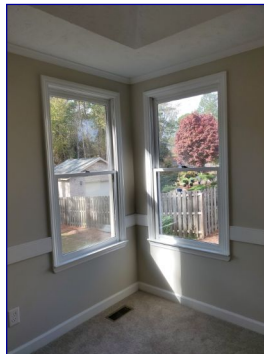
- The window would not raise. Recommend repair by a qualified technician.

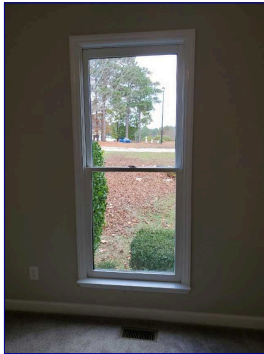
- The bedroom egress is restricted in bedroom 2, which is a safety concern. Recommend repair by qualified technician.

The bedroom egress is restricted in bedroom 2, which is a safety concern. Recommend a licensed contractor repair.

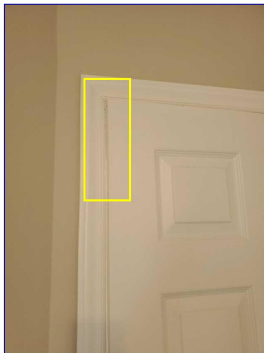
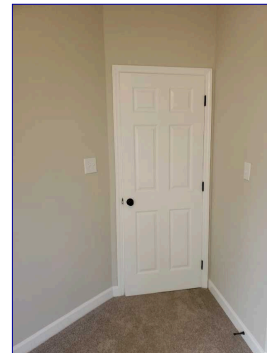
- The bedroom door would not latch. Recommend a professional contractor repair as needed.

The bedroom door would not latch. Recommend a professional contractor repair as needed.

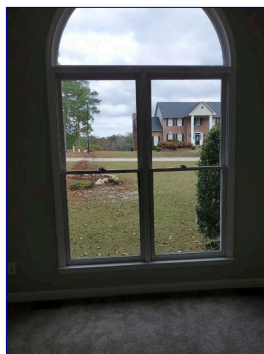
- Egress:
- Egress restricted: Yes
- Observations:
- The bedroom egress is restricted in bedroom 3, which is a safety concern. Recommend repair by a qualified technician.

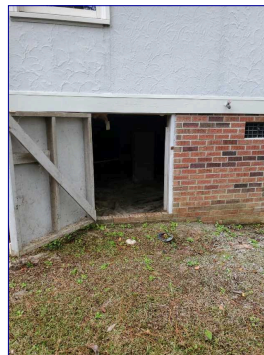
- Materials:
- Concrete block
- Observations:
- Moisture stains present in the crawl space. Monitor and consult a licensed professional as needed.
  - There is efflorescence on the foundation walls. Recommend monitoring and consulting a licensed contractor to repair as needed.

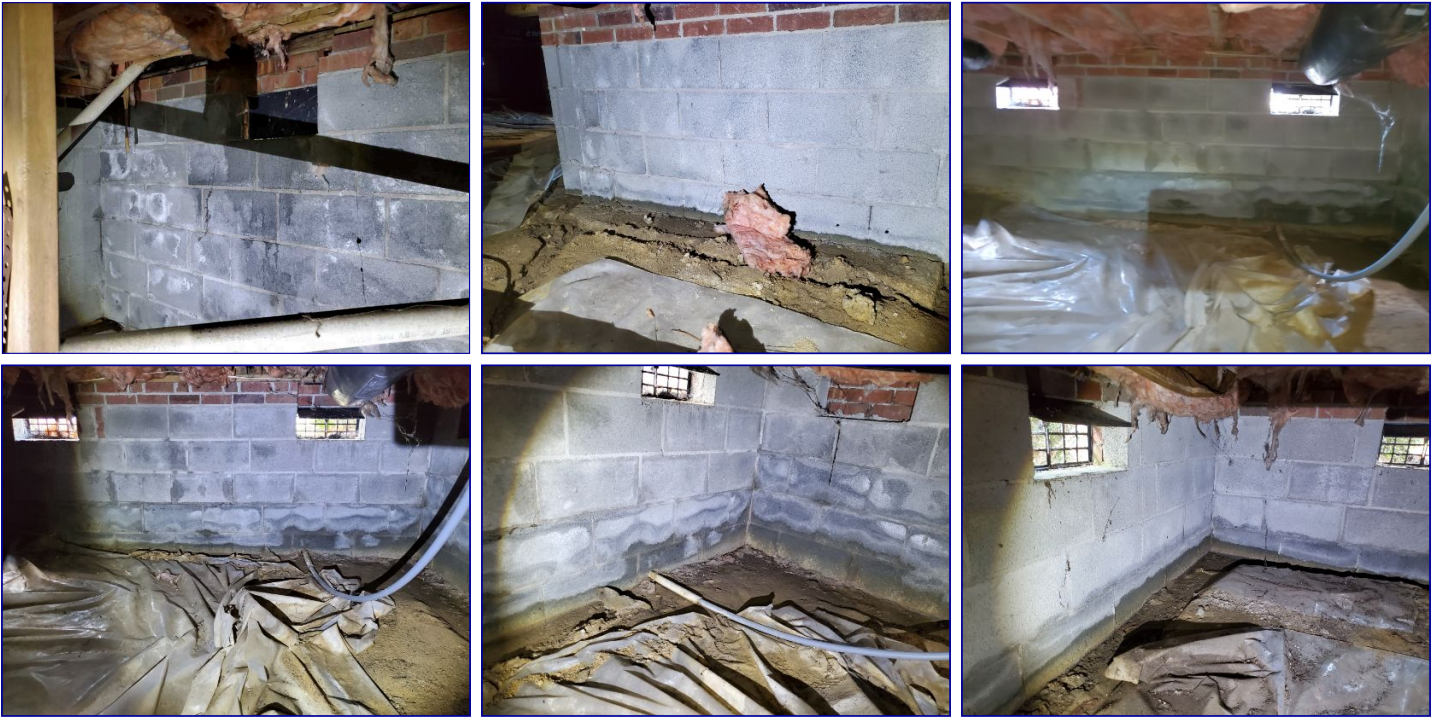
- Vapor barrier present, but in marginal condition. Recommend replacing by qualified technician.

Recommend a licensed contractor install a drain system and plastic vapor barrier to help protect the foundation walls and prevent moisture damage.

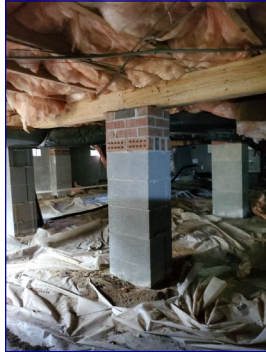
• Vapor barrier in crawlspace is not adequate. Overlap is improper. Much of the Vapor barrier is worn-out. Recommend replacing by qualified technician.

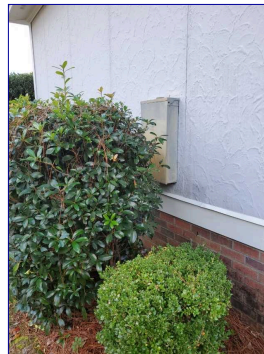
- There was insufficient clearance to the electrical panel. Recommend a clearance of 3 feet around the electric panel for added safety. Recommend removing items. Consult a professional contractor as needed.

There was insufficient clearance to the electrical panel. Recommend a clearance of 3 feet around the electric panel for added safety. Recommend removing items. Consult a professional contractor as needed.

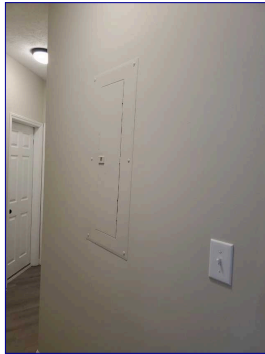
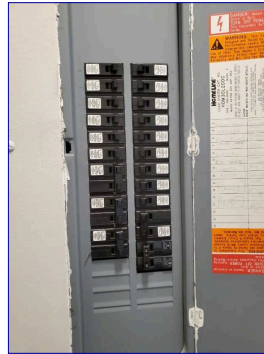
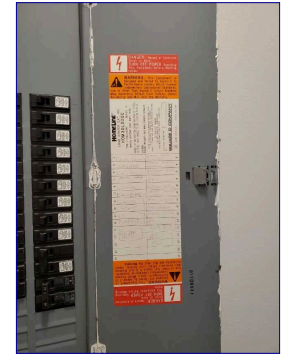
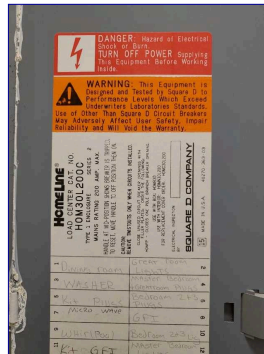
- Adequate Clearance to Panel: Yes

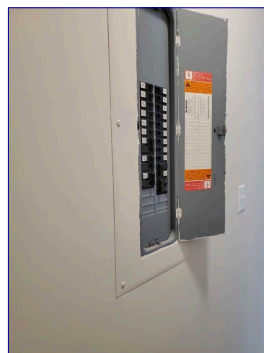
- Panel cover, (swad front) was not removed due to possible damage to wall.

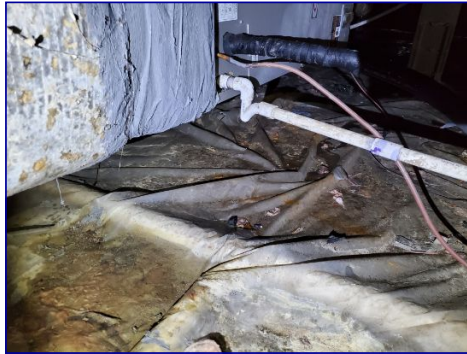
Secondary Condensate Line:  
• Present: No

• There is no secondary condensate protection installed on the air conditioner evaporator coil drain. This is a common practice, however, we recommend a licensed HVAC contractor install a secondary protection switch to help prevent damage to the furnace in the event that the drain becomes clogged and overflows.
