Property Inspection Report

Woodpecker Home Inspections

537 Lindsay
Inspection Prepared For: Pompilica Miller
Agent: John Powers - EXIT REALTY PREFERRED

Date of Inspection: 10/20/2022
Year Built: 41 Size: 1350
Weather: Partly Cloudy

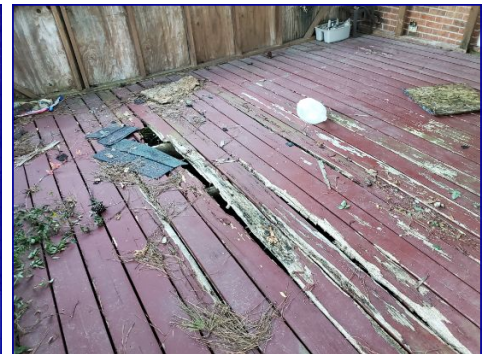
Deck floor is rotted

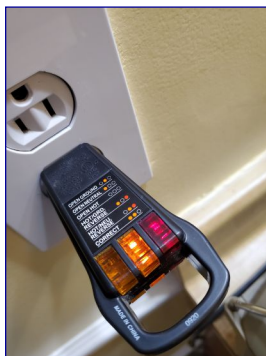
• There is at least one receptacle in the kitchen with reverse polarity, which is a safety concern. Recommend a licensed electrician repair.

Electrical receptacle showed reverse polarity. Left of sink.

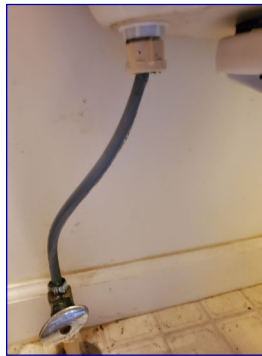
Toilet supply line leaking

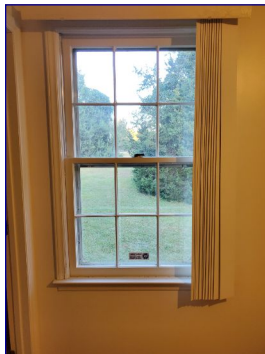
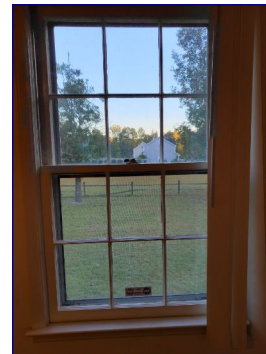
• The bedroom egress is restricted in bedroom 1, which is a safety concern. Recommend a licensed contractor repair.

Window would not open

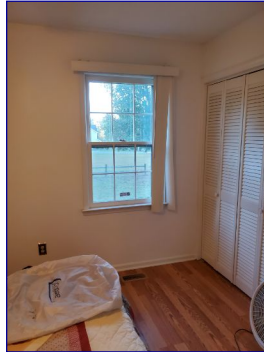
9. Window(s)

Window would not open

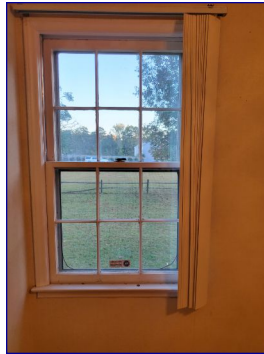
Window would not open

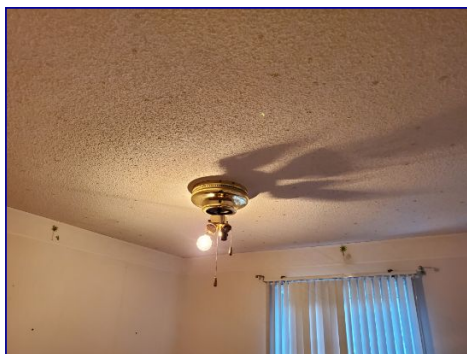
4. Ceiling Fan

This looks to be what was remaining of a ceiling fan.

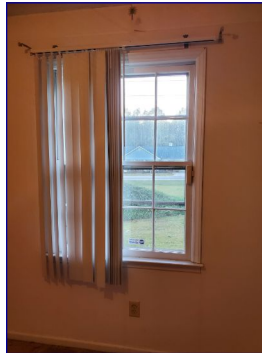
Window would not open
