Property Inspection Report

Woodpecker Home Inspections

537 Lindsay
Inspection Prepared For: Pompilica Miller
Agent: John Powers - EXIT REALTY PREFERRED

Date of Inspection: 10/20/2022
Year Built: 41 Size: 1350
Weather: Partly Cloudy

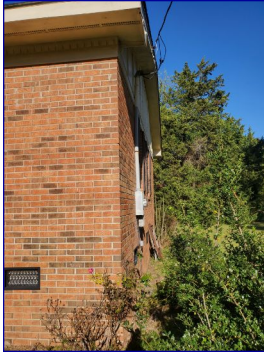
9. Landscape Affecting Foundation

- There is vegetation in contact with the house. Recommend trimming trees/vegetation, so it doesn't come into contact with the home.

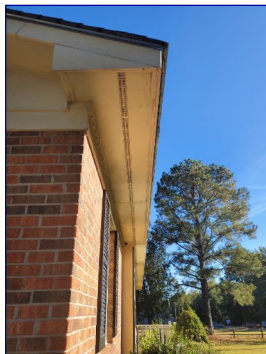
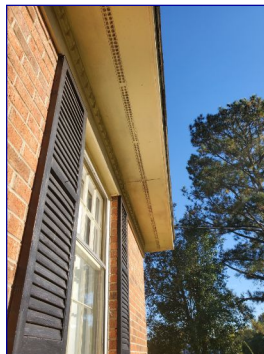
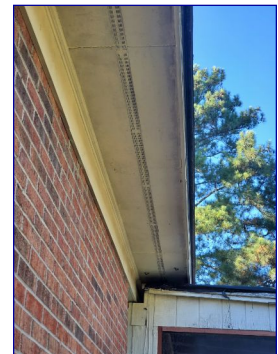
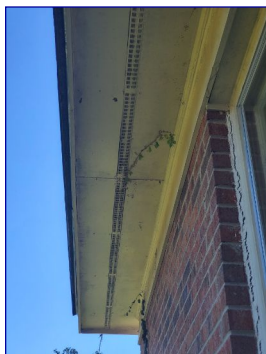
- The soffit needed routine painting maintenance. Recommend a professional painter repair/paint as needed.

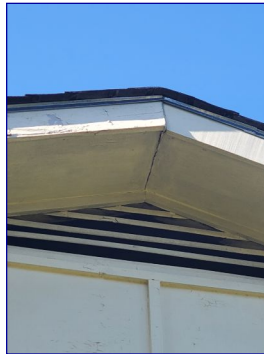
- Recommend caulking around windows, doors, corners, and utility penetrations to prevent moisture and pest intrusion.

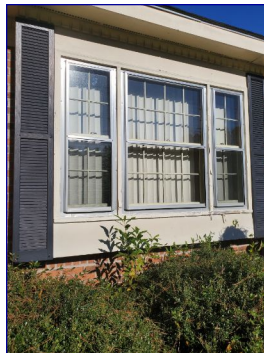
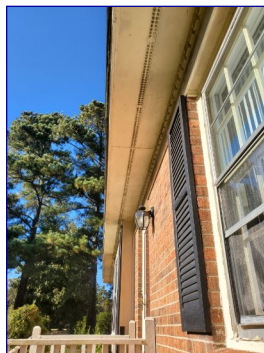
9. Windows/Screens

- Some window screens are torn, damaged, or missing. Repair as needed.

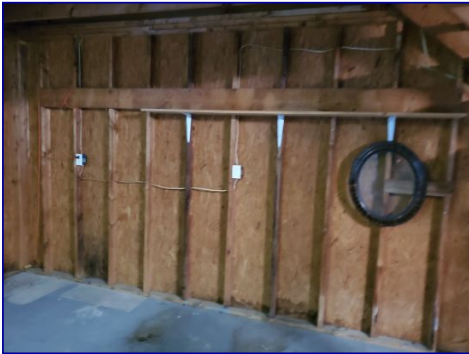
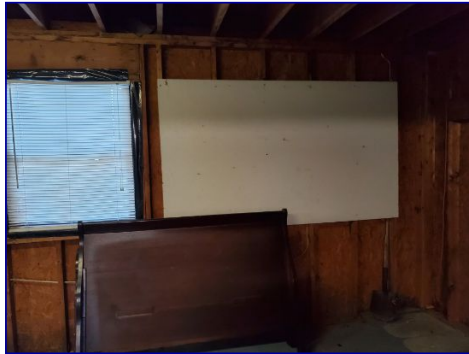
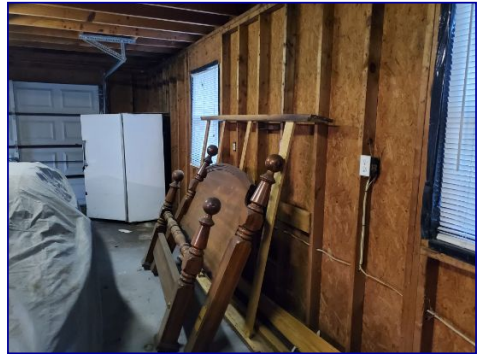
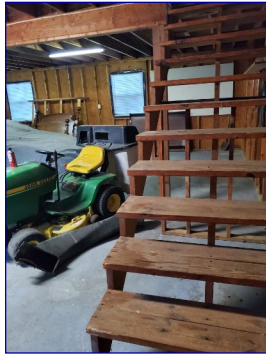
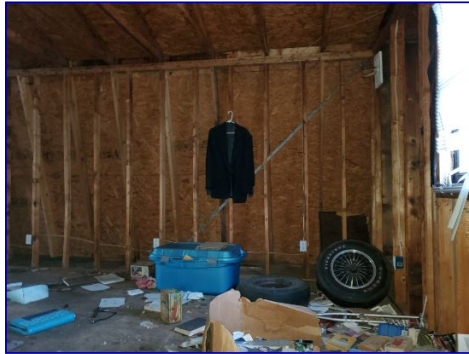
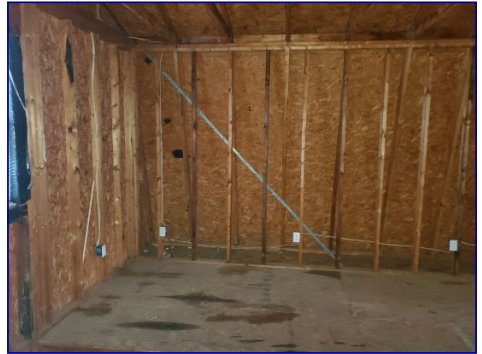
No railing on stairs, safety hazard

- The garage floor was covered with stored items. The floor could not be completely inspected. Monitor and repair as needed.
- The garage had a stair case going to the loft of the garage. The stairs were missing railings and balusters. This is a safety hazard. Recommend adding railing by a qualified technician.

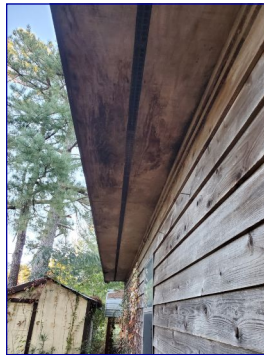
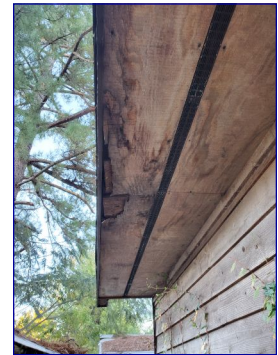
Delaminated soffit

- The garage exterior trim needed routine painting maintenance. Recommend a professional painter repair/paint the exterior trim.

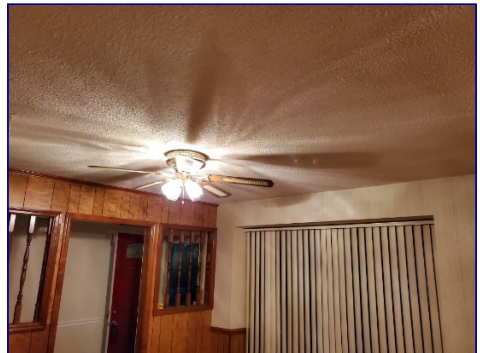
- The ceiling fans were making noise when operating. Repair or replace as needed.

Operated but made noise

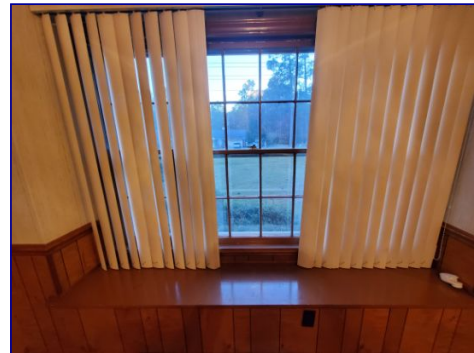
- One or more window springs are broken or would raise. Recommend a professional contractor repair.

Window would not raise

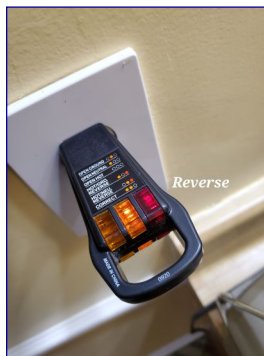
• There is at least one receptacle in the kitchen with reverse polarity, which is a safety concern. Recommend a licensed electrician repair.

Electrical receptacle showed reverse polarity. Left of sink.

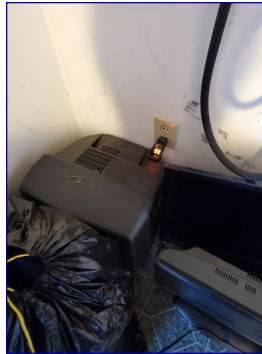
- GFCI receptacles are not installed in the laundry room, which is a safety concern. However, when the home was built, installing GFCI receptacles was not part of the standard building requirements. Recommend upgrading the GFCI receptacles to current standards for increased safety.

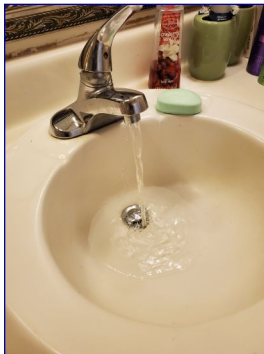
• Pipes are leaking in the bathroom 1. Recommend repair or replacement by a licensed plumber.

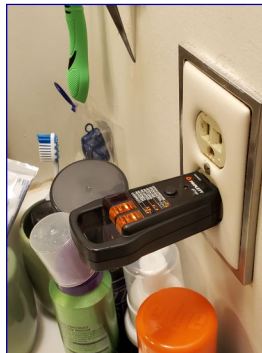
• Bathroom 1 is missing a GFCI, which is a safety concern. GFCI receptacles should be installed at all locations within six feet of water. Recommend a licensed electrician install GFCI receptacles. (Recommended since 1975)

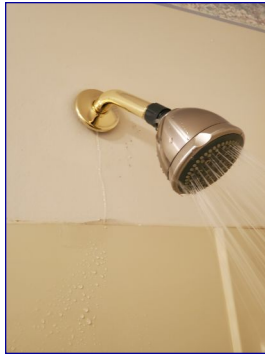
Shower head VERY loose.

Shower head VERY loose

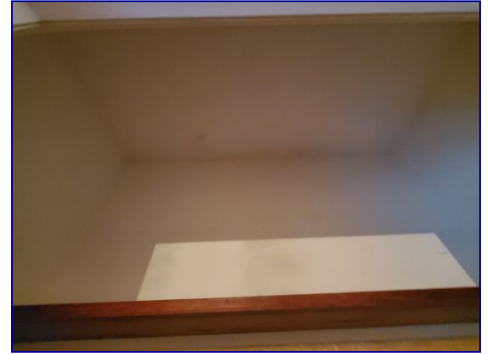
Closet ceiling

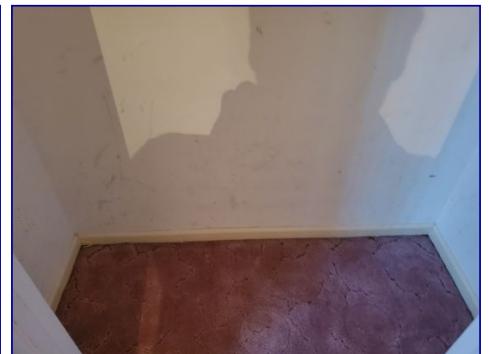
Closet floor

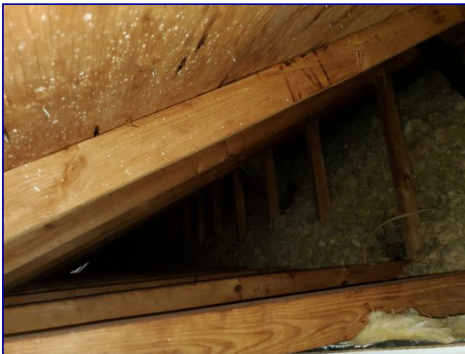
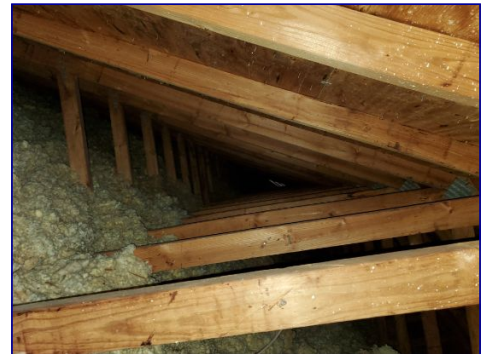
Possible moisture stains from previous roof leak

• There is staining and evidence of moisture on the roof sheathing as viewed from the attic. Possibly from a previous leak. There were no evidence of active leak..

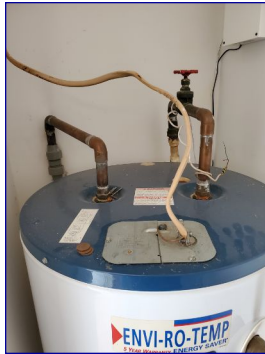
Power supply is electric
